Clinical Case Review

Assessment of Vasospasm Following Ruptured Aneurysm Using Vitrea® Software

Jeffrey S. Carpenter, MD

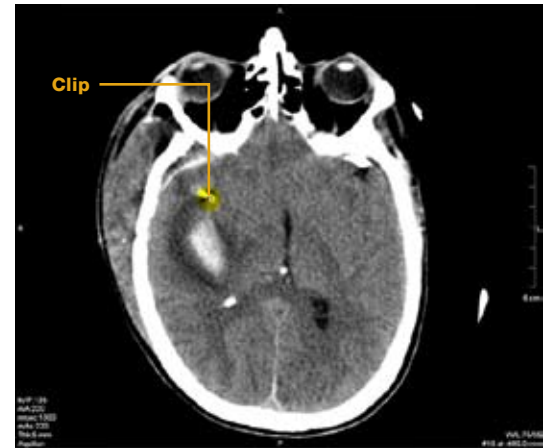
Figure 1: Identification of Aneurysm Clip

Volumes were loaded into the Vitrea® system using the CT Stroke Protocol. Some abnormalities were expected in the images due to the recent aneurysm rupture. The aneurysm clip was visualized in the Sylvian fissure (see Figure 1), the craniotomy in the parietal region and post-surgical scalp changes (see Figure 2). The parenchymal hemorrhage that occurred when the aneurysm ruptured (see Figure 2) was also visualized.

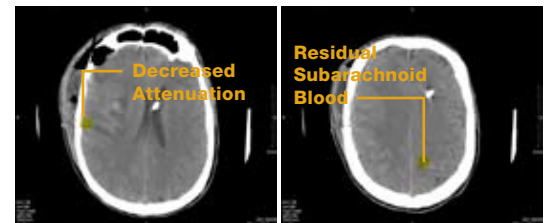
Figure 4: Evaluation of Left Hemisphere

Because the patient's new symptoms were on the right side, the left MCA distribution was studied more than the right. While the left hemisphere was unremarkable, the patient did have some residual subarachnoid blood (see *Figure 4*) nine days out.

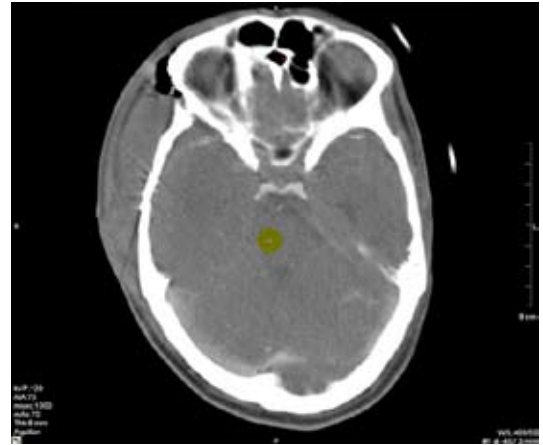
Figure 5: Assessment of Motion Artifact in First Data Set

Next, the first of two separately acquired data sets of CT perfusion imaging were loaded using the Brain Perfusion CT protocol. It was not an ideal data set due to the amount of motion artifact (see *Figure 5*). (It is not uncommon to get this degree of head motion in patients that are ill and experiencing symptoms.) After running Motion Correction, a good artery and a good vein were segmented, rendering it a diagnostic study even with a noisy data set.

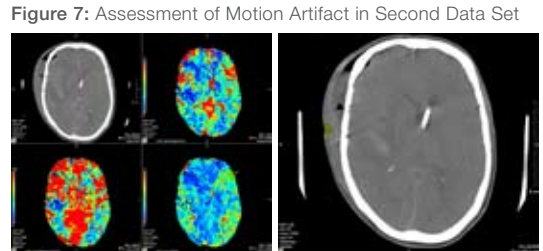
Figure 6: Computation of Volumes from the First Data Set

At this point, volumes were generated, and the axis adjusted through the images. The study was deemed diagnostically useful due to the availability of mean transit value information. In regard to MCA distribution on the left, mean transit times were relatively increased compared to the right. Cerebral blood flow also appeared to be decreased around the hematoma and in the area of decreased attenuation on the right (see *Figure 6*).

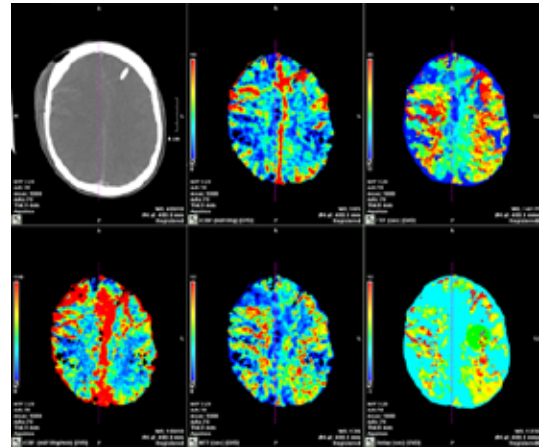
Figure 9: Delay and Time-to-Peak Maps

Using the Delay and Time-to-Peak maps (see Figure 9), heterogeneity throughout was observed, supporting the presence of vasospasm.

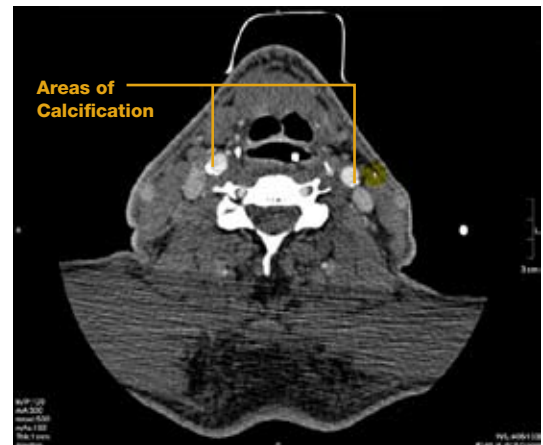
Figure 10: Observation of Atherosclerotic Disease

The CT angiogram (CTA) was used to locate the area of vasospasm. Because the cause of perfusion abnormalities for this patient were known, the images were viewed more quickly than with a stroke case. While doing so, extensive atherosclerotic disease was observed involving the carotid origins (see Figure 10). The disease on the left was relatively impressive for a 48-year-old and measured out to be around 65%. Therefore, secondarily addressing the carotid disease following the acute phase of vasospasm was recommended.

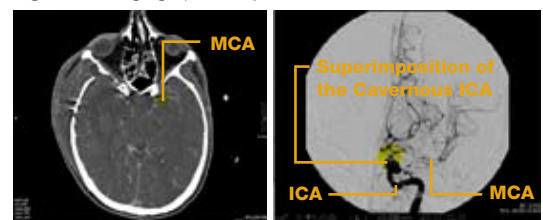
Figure 12: Angiographic Projection of Frontal Left Side

Next, the angiogram was loaded in Softread to evaluate vascular interventions (see Figure 12). In the frontal projection of the left side, some narrowing of the distal internal carotid artery (ICA) at the superclinoid and an extremely thin left MCA was visualized, which was responsible for the patient's symptoms. Relatively delayed filling time at the borders of the brain indicated the need for angioplasty.

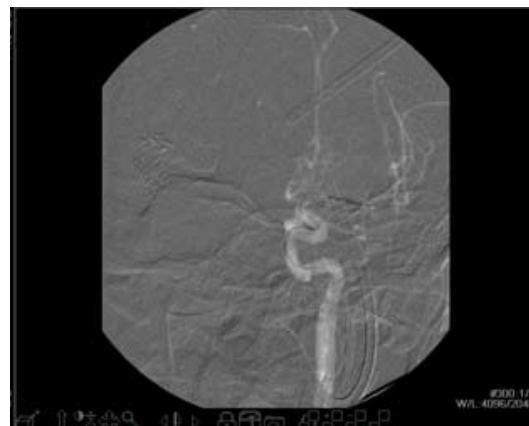
Figure 13: Calcifications in Cavernous ICA

Angioplasty was conducted with a 4 mm x 10 mm Hyperglide™ in the MCA by passing through the M1 segment and conducting dilatations both there and within the distal ICA (see Figure 13).

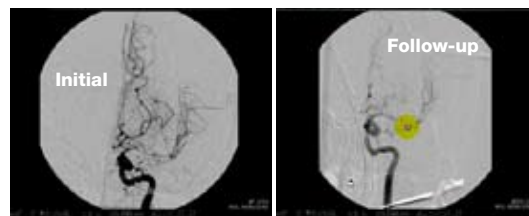
Figure 14: Observation of Medial Course

On the follow-up angiogram, increased caliber of the MCA and distal ICA (see Figure 14) were observed. (Right-sided angioplasty of the MCA was also conducted, but only the left side is depicted for brevity.) Angioplasty cannot reach distal branch involvement of vasospasm. Even so, some increased flow in this region was observed and administration of calcium channel blockers (CCBs) was recommended for a case this severe.

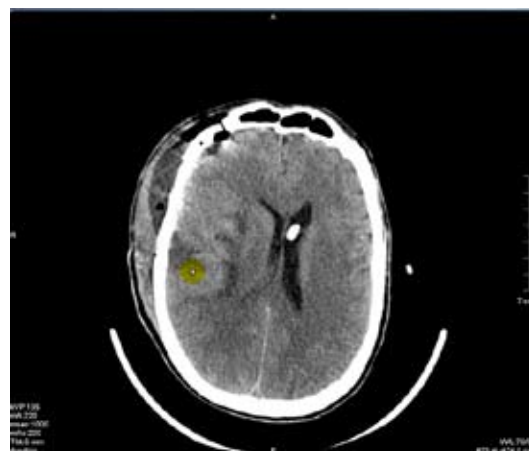
Figure 15: Identification of Clot at M1 Segment of MCA

On the follow-up CT (see Figure 15), a small infarct around the intraparenchymal hematoma from the ruptured aneurysm on the right side was visualized. The left side never did develop any infarcts, so the left hemisphere was salvaged.
