Clinical Case Review

Cardiac Assessment of Mechanical Valve Function Using Vitrea® Software

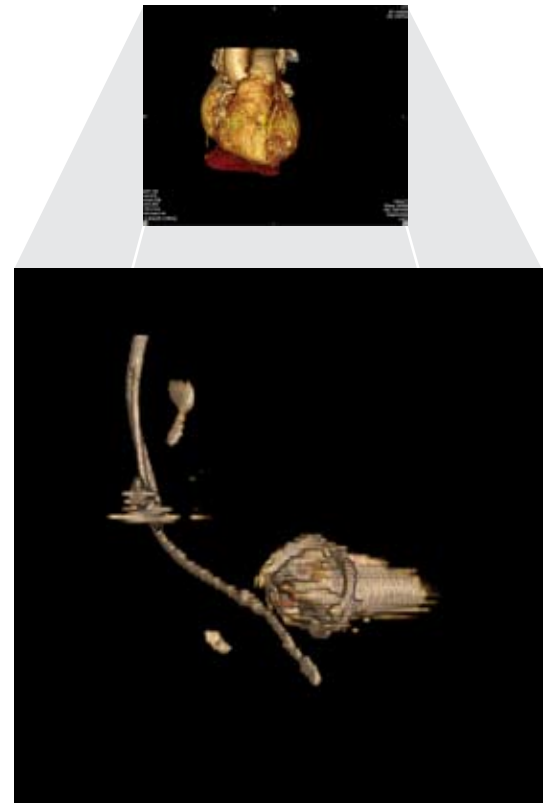
Figure 1: Removal of Soft Tissue and Artifacts to Visualize Valve

Using the Cardiac Arteries protocol, the Vitrea® software generated a 3D color image. The evaluation began by reducing the image quality to maximize workstation speed. The Window Level function was used to remove all soft tissues and artifacts to isolate the pacemaker wires and mechanical valve (see Figure 1).

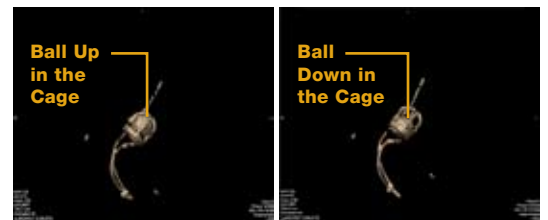
Figure 2: Observation of Valve Movement

The valve function was then assessed by observing it in motion (see Figure 2). The valve was functioning normally.

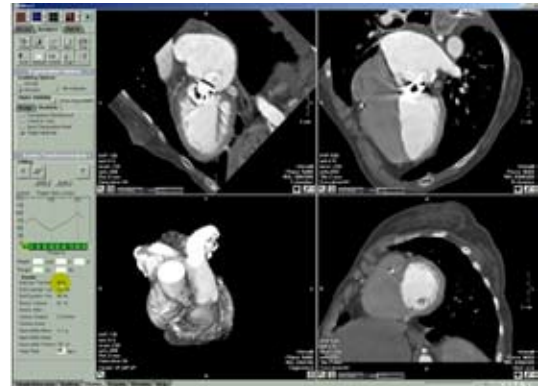
Figure 3: Calculation of EF

Cardiac function was then assessed using the same view seen in echocardiography (see *Figure 3*). Ejection fraction (EF) calculation was at 60%.

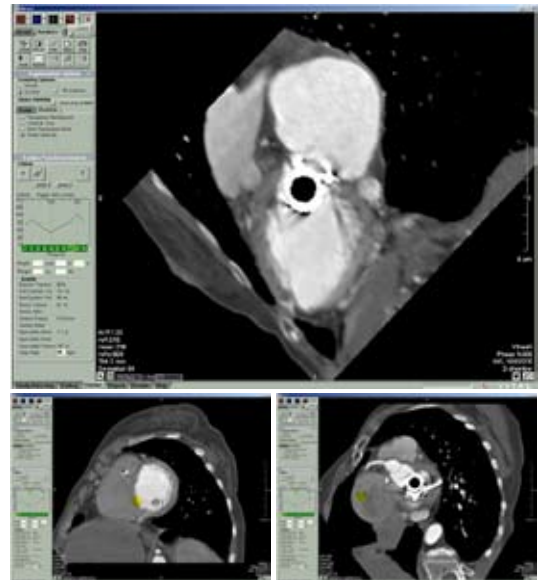
Figure 4: Confirmation of EF Calculation

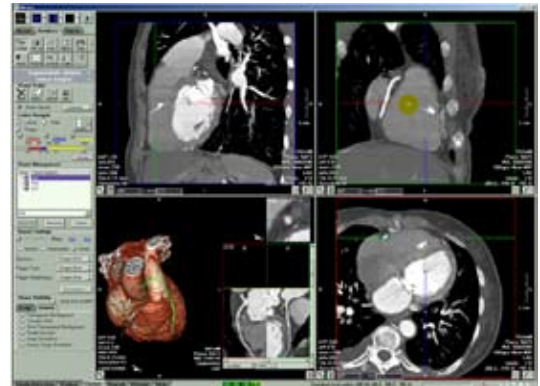
Figure 5: Rendering of RCA at Phase 75%

Misregistration artifact was assessed during segmentation and selected best phase based on the appearance of mid RCA. Despite the patient's high heart rate and presence of artifacts, it was noted that Phase 75% rendered the perfect RCA (see *Figure 5*).

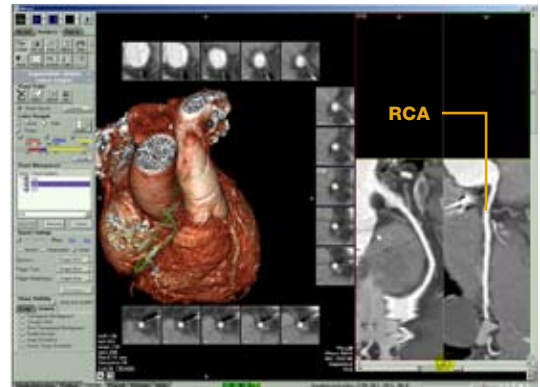
Figure 6: Analysis of Vasculature

Once respiratory artifact and coronary anomalies were ruled out, vascular analysis of the RCA, LAD and LCX vessels were performed, which were all unremarkable (see *Figure 6*).
