# Clinical Case Review

## Assessment of Vasospasm Following Ruptured Aneurysm Using Vitrea® Software

### Jeffrey S. Carpenter, MD

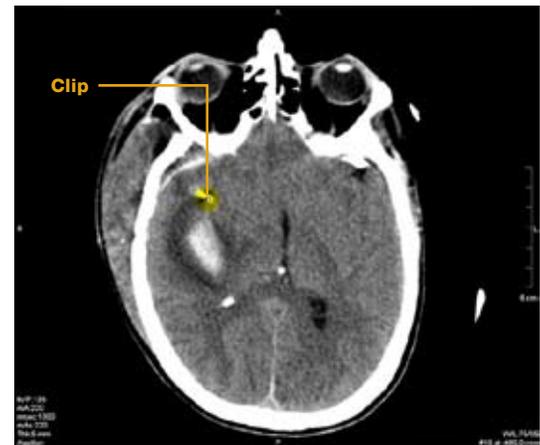
Figure 1: Identification of Aneurysm Clip

Volumes were loaded into the Vitrea® system using the CT Stroke Protocol. Some abnormalities were expected in the images due to the recent aneurysm rupture. The aneurysm clip was visualized in the Sylvian fissure (see Figure 1), the craniotomy in the parietal region and post-surgical scalp changes (see Figure 2). The parenchymal hemorrhage that occurred when the aneurysm ruptured (see Figure 2) was also visualized.

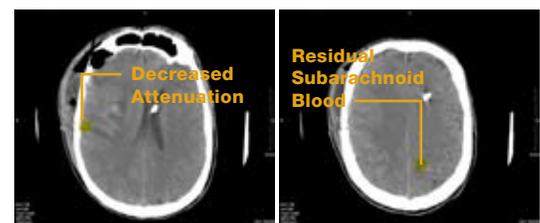
Figure 4: Evaluation of Left Hemisphere

Because the patient's new symptoms were on the right side, the left MCA distribution was studied more than the right. While the left hemisphere was unremarkable, the patient did have some residual subarachnoid blood (see Figure 4) nine days out.

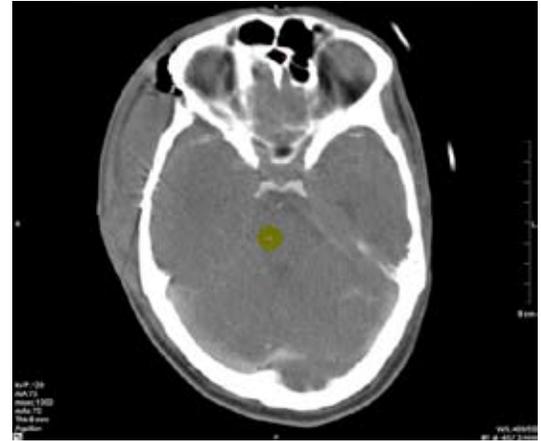
Figure 5: Assessment of Motion Artifact in First Data Set

Next, the first of two separately acquired data sets of CT perfusion imaging were loaded using the Brain Perfusion CT protocol. It was not an ideal data set due to the amount of motion artifact (see Figure 5). (It is not uncommon to get this degree of head motion in patients that are ill and experiencing symptoms.) After running Motion Correction, a good artery and a good vein were segmented, rendering it a diagnostic study even with a noisy data set.

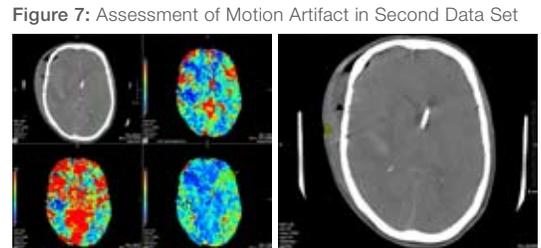
Figure 6: Computation of Volumes from the First Data Set

At this point, volumes were generated, and the axis adjusted through the images. The study was deemed diagnostically useful due to the availability of mean transit value information. In regard to MCA distribution on the left, mean transit times were relatively increased compared to the right. Cerebral blood flow also appeared to be decreased around the hematoma and in the area of decreased attenuation on the right (see Figure 6).

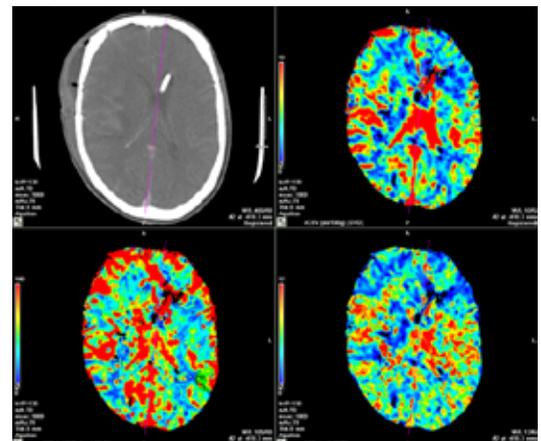
Figure 8: Computation of Volumes from the Second Data Set

After running Motion Correction and segmenting the vessels, the another diagnostically useful volumes set were generated (see Figure 8). While the images weren't ideal, the typical appearance of diffuse vasospasm as patchy involvement of mean arterial times in the anterior cerebral arteries and MCA territory were visualized. Up higher, areas of involvement interdigitated with uninvolved areas were observed. Intervention was required given the new onset of symptoms in this case.

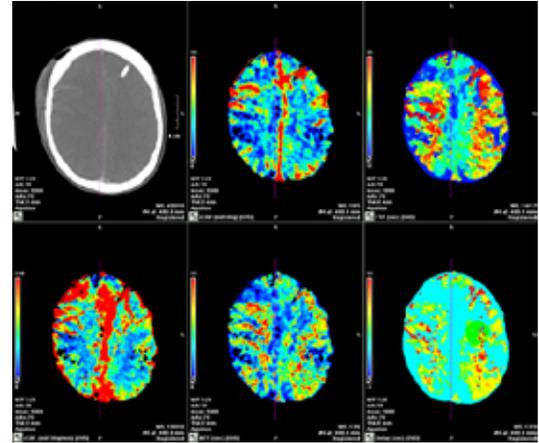
Figure 9: Delay and Time-to-Peak Maps

Using the Delay and Time-to-Peak maps (see Figure 9), heterogeneity throughout was observed, supporting the presence of vasospasm.

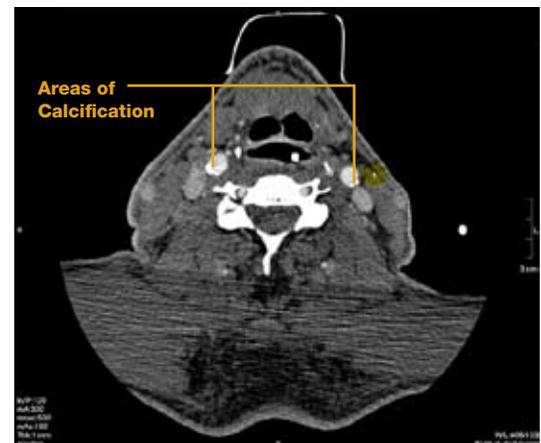
Figure 10: Observation of Atherosclerotic Disease

The CT angiogram (CTA) was used to locate the area of vasospasm. Because the cause of perfusion abnormalities for this patient were known, the images were viewed more quickly than with a stroke case. While doing so, extensive atherosclerotic disease was observed involving the carotid origins (see Figure 10). The disease on the left was relatively impressive for a 48-year-old and measured out to be around 65%. Therefore, secondarily addressing the carotid disease following the acute phase of vasospasm was recommended.

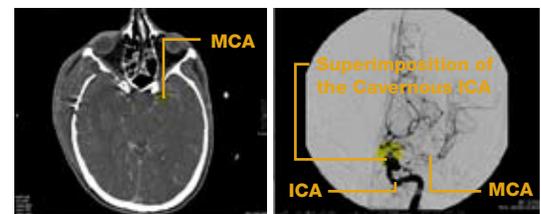
Figure 12: Angiographic Projection of Frontal Left Side

Next, the angiogram was loaded in Softread to evaluate vascular interventions (see Figure 12). In the frontal projection of the left side, some narrowing of the distal internal carotid artery (ICA) at the superclinoid and an extremely thin left MCA was visualized, which was responsible for the patient's symptoms. Relatively delayed filling time at the borders of the brain indicated the need for angioplasty.

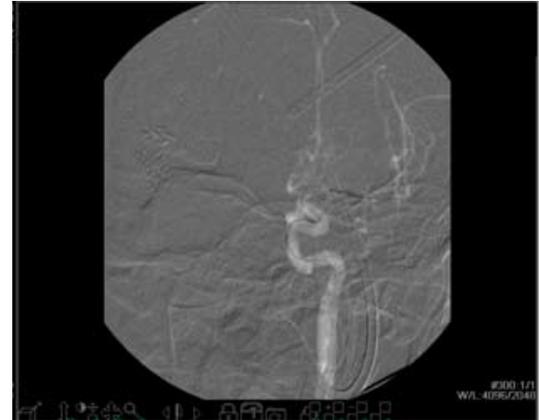
Figure 13: Calcifications in Cavernous ICA

Angioplasty was conducted with a 4 mm x 10 mm Hyperglide™ in the MCA by passing through the M1 segment and conducting dilatations both there and within the distal ICA (see Figure 13).

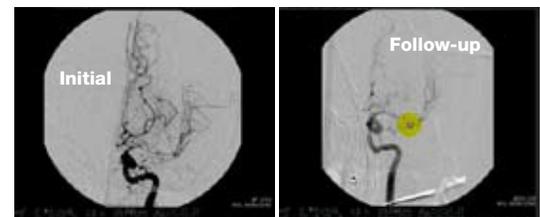
Figure 14: Observation of Medial Course

On the follow-up angiogram, increased caliber of the MCA and distal ICA (see Figure 14) were observed. (Right-sided angioplasty of the MCA was also conducted, but only the left side is depicted for brevity.) Angioplasty cannot reach distal branch involvement of vasospasm. Even so, some increased flow in this region was observed and administration of calcium channel blockers (CCBs) was recommended for a case this severe.

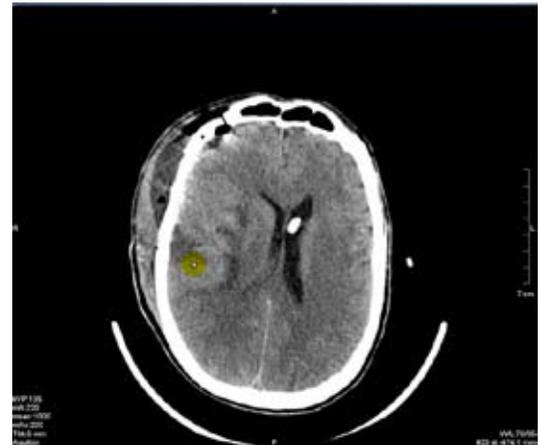
Figure 15: Identification of Clot at M1 Segment of MCA

On the follow-up CT (see Figure 15), a small infarct around the intraparenchymal hematoma from the ruptured aneurysm on the right side was visualized. The left side never did develop any infarcts, so the left hemisphere was salvaged.
