# Clinical Case Review

## Assessment of Bypass Graft Patency and Mechanical Valve Function in a Patient with Unusual Anatomy Using Vitrea® Software

### Wojciech Mazur, MD, FACC

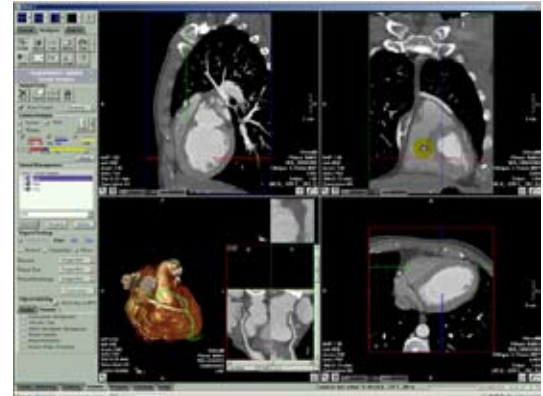
Figure 1: Quality Assessment Using Contrast Intensity

Using the Cardiac Arteries protocol, the Vitrea® software generated a 3D color image. The evaluation began by making a quality assessment of the original CT images while segmentation was in process. Contrast intensity exceeded 250 throughout the entire ventricle (see Figure 1).

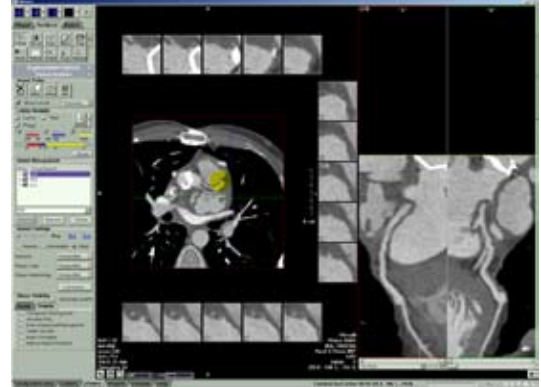
**Figure 4:** Orthogonal View for Assessment of Ostial Coronary Anatomy

A bypass graft attached to the LAD (see Figure 3) was visualized and properly tracked through the native vessel in the left coronary system. Ligation of the left main artery was observed and confirmed using the orthogonal view (see Figure 4).

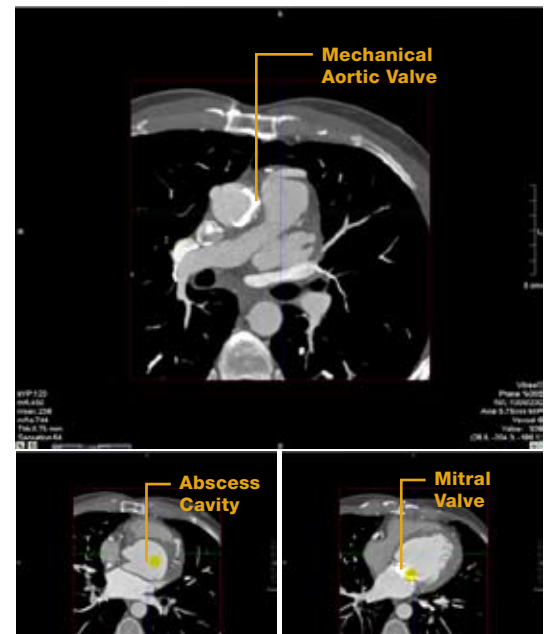
Figure 11: Continuation of Cardiac Morphology Review

Finally, the Vessel Probe function was turned off to review cardiac morphology (see Figure 10 and Figure 11). High placement of the aortic valve was noted, as well as the extensive size of the old abscess cavity.
