# Clinical Case Review

## Assessment of Multi-Vessel Coronary Artery Disease Using Vitrea® Software

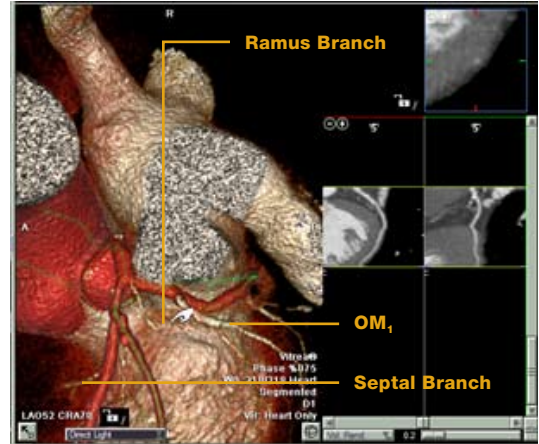
Figure 4: Evaluation of LM
